Effects of Ground Failure on Bridges, Roads, and Railroads

The long duration and strong velocity content of the motions produced by the 27 February 2010 Maule earthquake resulted in widespread liquefaction and lateral spreading in several urban and other regions of Chile. In particular, critical lifeline structures such as bridges, roadway embankments, and railroads were damaged by ground shaking and ground failure. This paper describes the effects that ground failure had on a number of bridges, roadway embankments, and railroads during this major earthquake. [DOI: 10.1193/1.4000024]

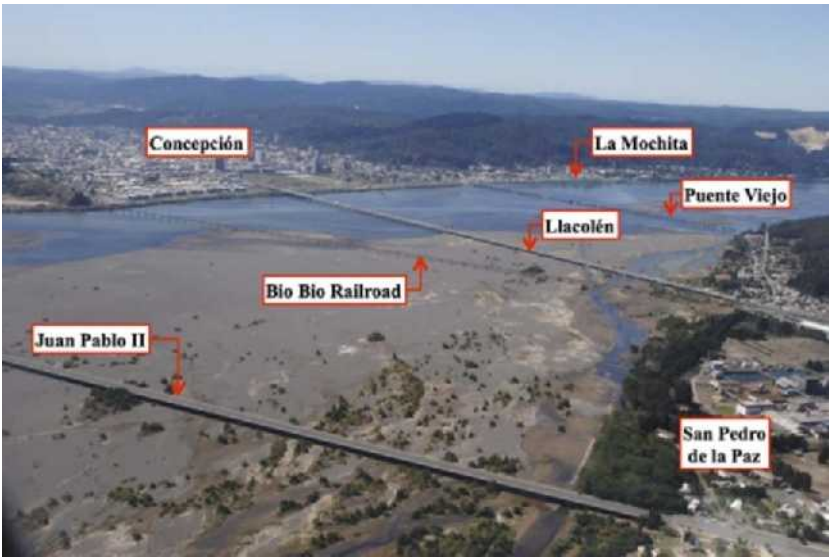
Figure 2. Aerial view of Concepción metropolitan area and Bio-Bío River main crossings.

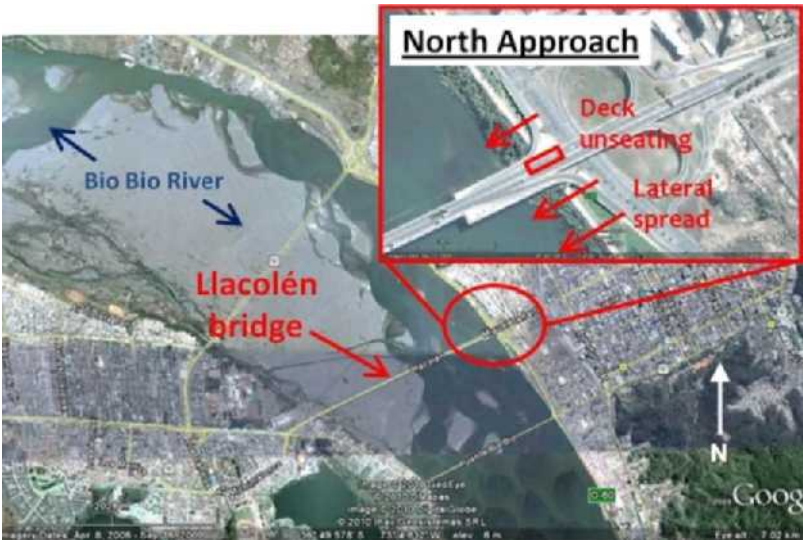
Figure 3. Plan view of the Bio-Bío River region, locating the damaged region of the Llacolén Bridge in Concepción ($S36.830108^{\circ}$ $W73.067991^{\circ}$).

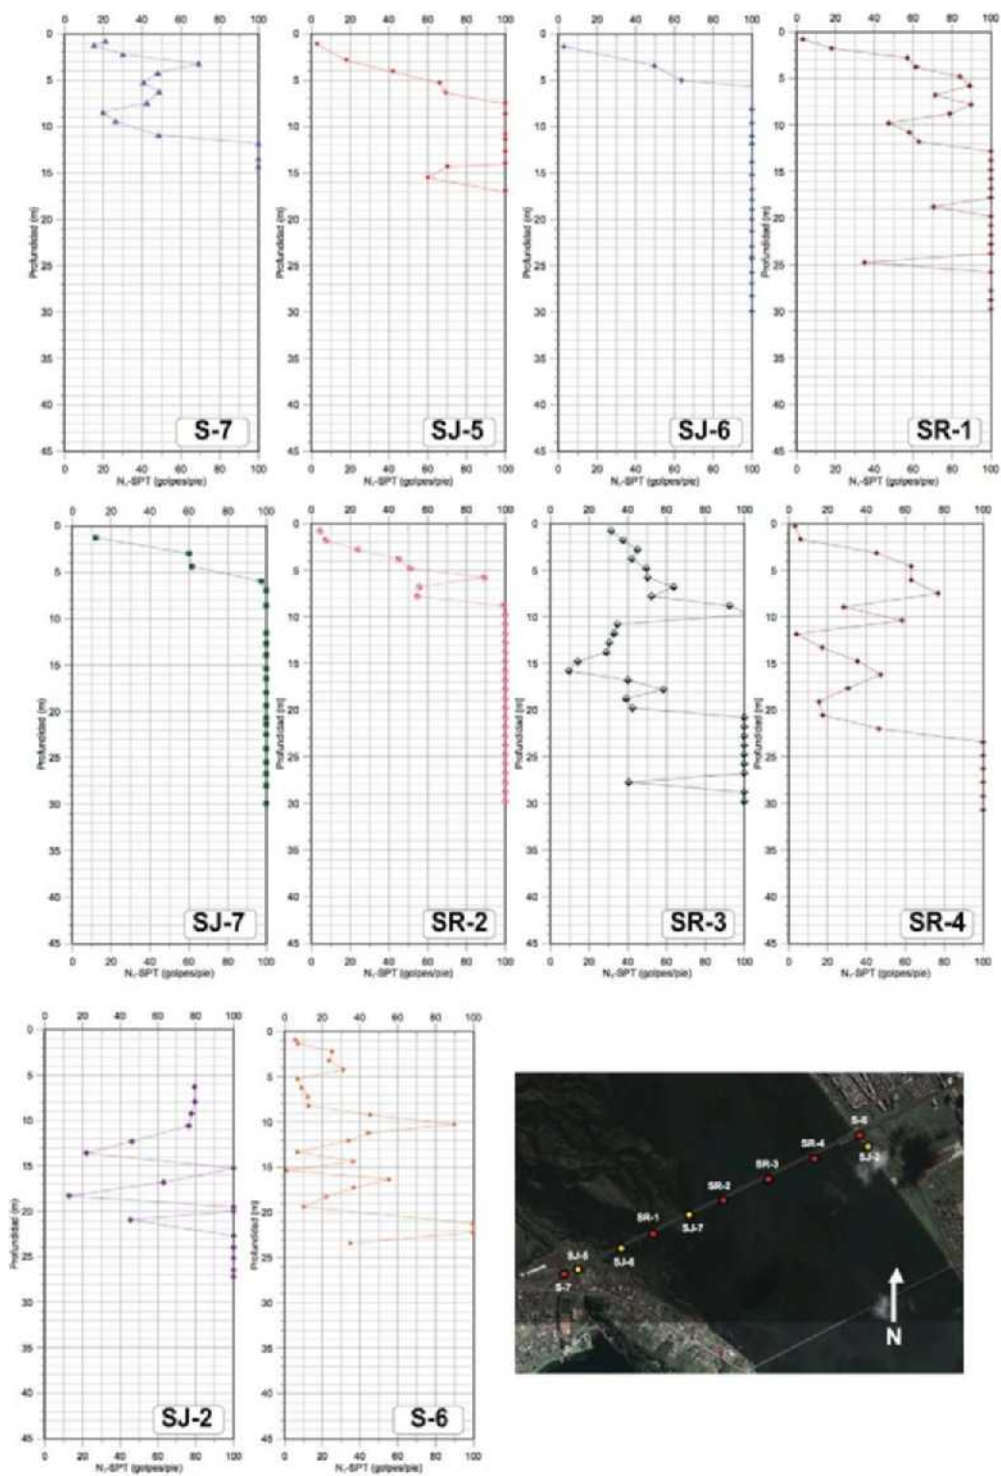
As a measure of liquefaction susceptibility, the sand liquefaction triggering relationship of [Youd et al. \(2001\)](#) can be used to define a normalized SPT threshold value for the occurrence of liquefaction. The recorded peak ground accelerations in downtown Concepción were about 0.4g ([Boroschek et al. 2010](#)), and assuming that these soils may have a fines content on the order of 5% to 15%, an average stress reduction coefficient of about 0.9, a magnitude scaling factor of 0.75, and a σ_v/σ'_v ratio of about 2, the [Youd et al. \(2001\)](#) procedure estimates that sands with normalized SPT values below approximately 30 blows/foot were likely to liquefy during this event. Figure 7 shows that liquefiable soils were present along the Llacolén Bridge at many depths especially within the upper 3 m to 5 m. At the north approach, where earthquake-induced damage was concentrated, Boring S-6 indicates that liquefiable soils were present in the upper 8 m to 9 m of the soil deposit.

Figure 7. Normalized SPT values and boring locations at Llacolén Bridge. Pre-earthquake data (Verdugo and Peters 2010). “Profundidad (m) = Depth (m),” “(golpes/pie) = (blows/foot).”

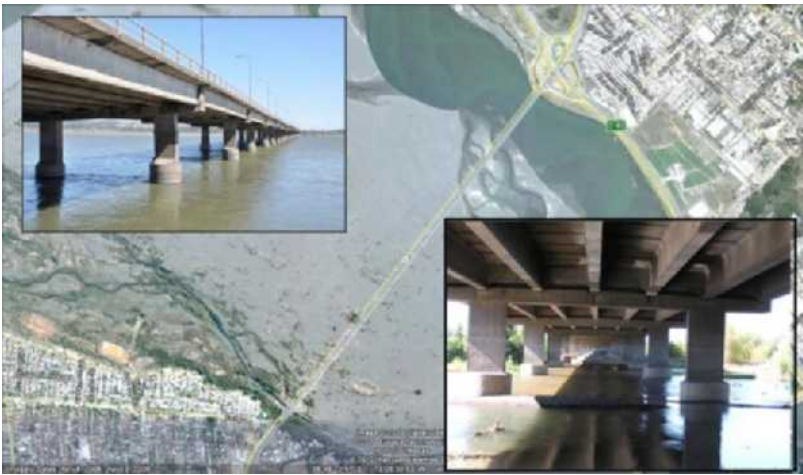
Paz across the Bío-Bío River. The bridge opened to the public in 1974. The bridge consists of 70 spans (length = 33 m, width = 21.9 m), each composed of 7 reinforced concrete girders and a concrete deck. Each span sits on reinforced concrete bents with drilled pier supports (see Figure 8).

During the earthquake, the bridge suffered severe damage and was closed to the public. Liquefaction and lateral spreading at the northeast approach resulted in significant damage to the bridge superstructure (Figure 9). Most notably, liquefaction caused large settlements at several support piers and lateral displacement of the bridge deck. Visual inspection of the surrounding soils indicated the presence of fine loose sands. Several sand boil deposits with

Figure 8. Juan Pablo II Bridge connecting the cities of Concepción and San Pedro de la Paz across the Bío-Bío River. Typical bridge bent configuration shown in photograph inset.

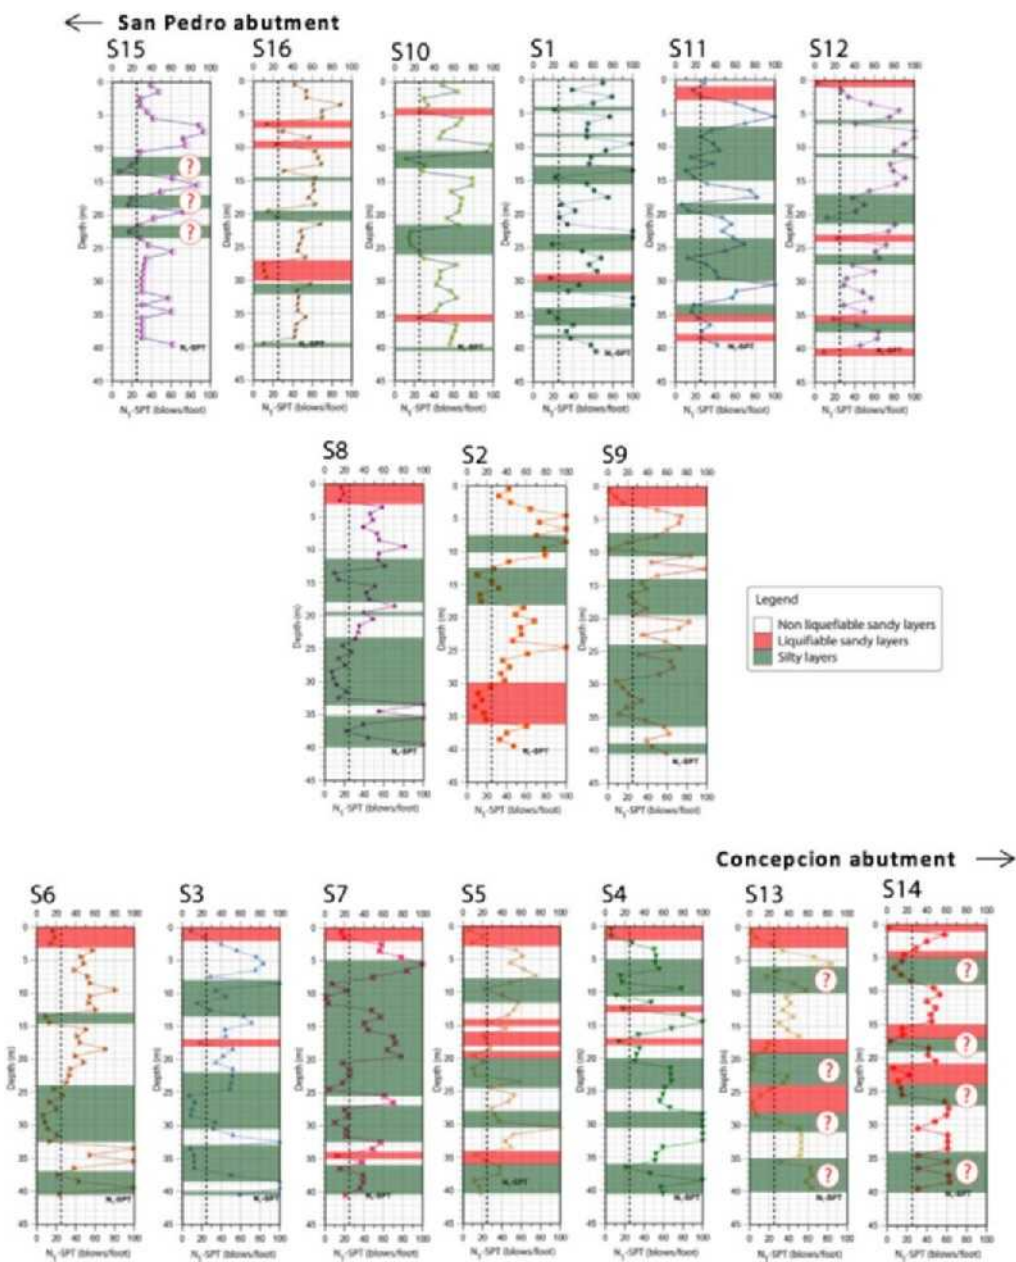
piers showed evidence of ejected water and sand, while soil immediately surrounding the pier was depressed with standing water covering an annular zone around the pier. These observations are supported by the SPT profiles obtained after the earthquake along the bridge, shown in Figure 13, where the white color corresponds to non-liquefiable sands, green is for soils with a high content of non-plastic silts (termed as “non-liquefiable” in the report), and red is for liquefiable sands, according to the criteria used by Verdugo and Peters (2010) in their geotechnical report. Using the 30 blows/foot criterion discussed in the previous section, distinct layers of liquefiable material can be observed on the geotechnical cross-section along the Juan Pablo II Bridge.

Figure 13. Normalized SPT values at Juan Pablo II Bridge (post-earthquake data). White is for non-liquefiable sands, green is for silty soils (mainly non-plastic silts), and red is for liquefiable sands (Verdugo and Peters 2010).

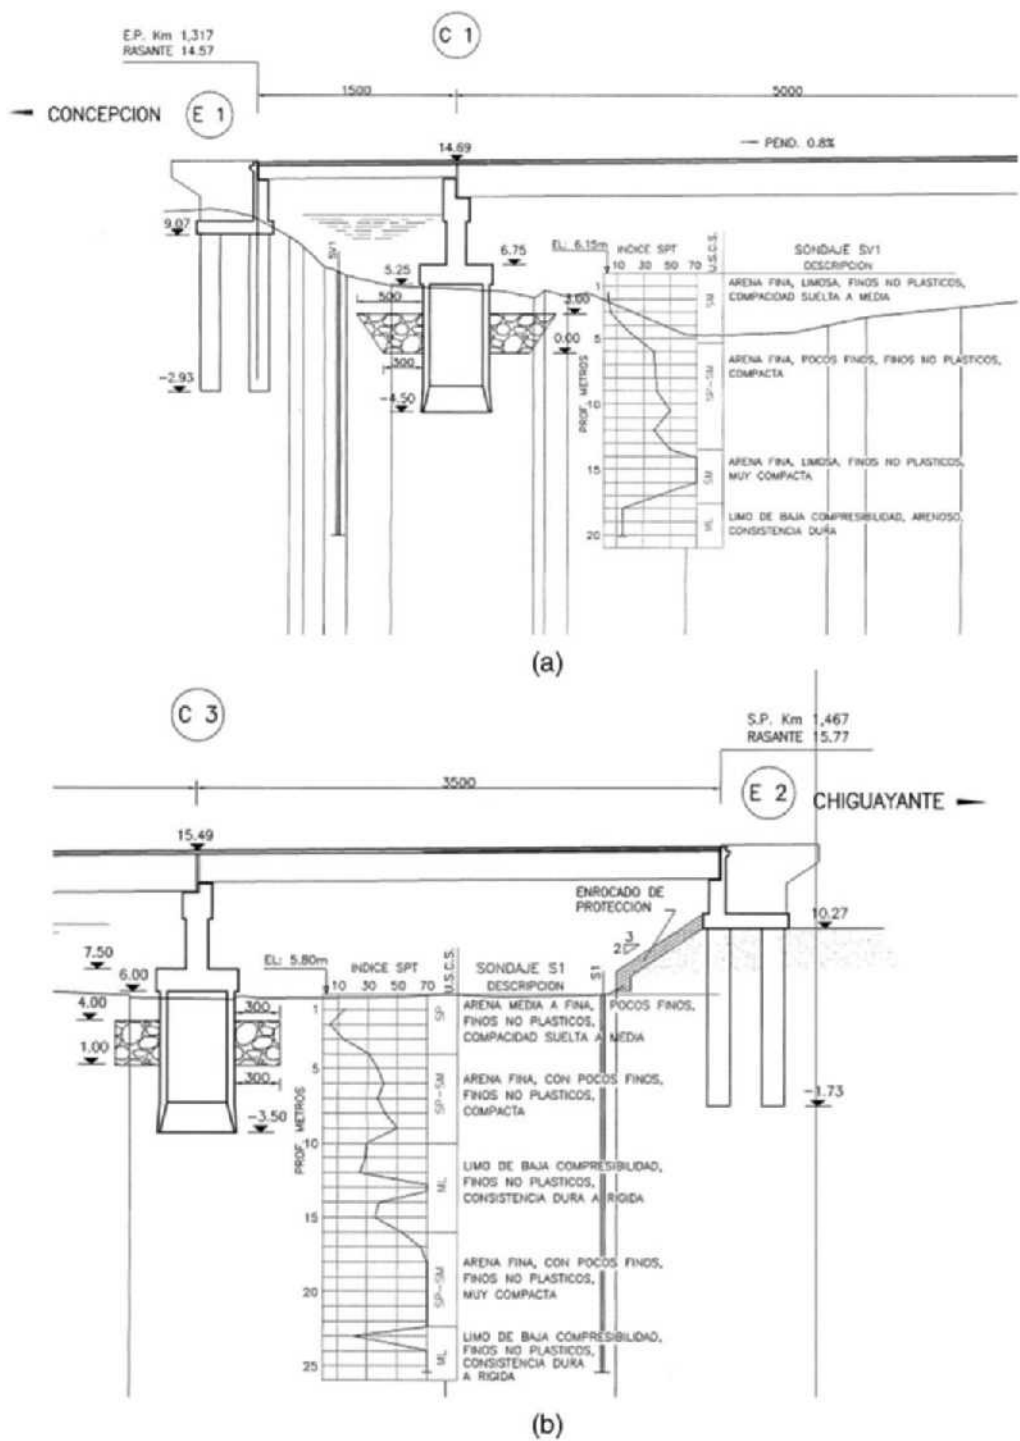
The bridge superstructure shifted transversely, largely as a unit, toward the east due to failure of the soil spit (Figure 16a). This failure may be attributable to either a deep-seated slope instability or a liquefaction-induced lateral spreading mechanism. The SPT profiles from the original project (Figure 15) show that the deep-seated slope instability is a possible mechanism of failure (note how the SPT values drop at depths of 15 m to 20 m). However, sand boils below the bridge were observed near bents #2 and #3 (Figure 16b), and the transverse rotation, or vertical movement, of the bents was limited, which suggests that liquefaction-induced lateral spreading could have also played a role in the bridge failure.

Figure 15. SPT profiles at both ends of La Mochita Bridge (pre-earthquake data): (a) Concepción abutment and (b) Chiguayante abutment (MOP 2010).

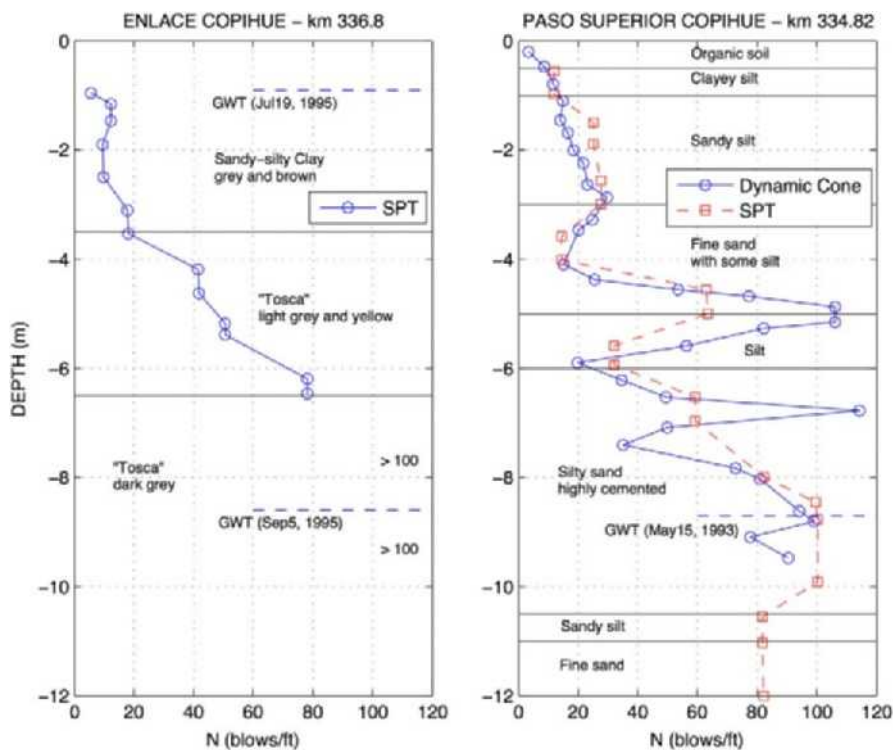
Two collapsed embankment fills were identified near Copihue and Parral. The first, shown in Figure 18, occurred along a straight section of Ruta 5 located approximately 8 km north of Parral. The southbound lanes collapsed to the west, apparently as a result of a shallow translational slide in near-surface foundation soils (~ lateral spreading), as evidenced by the failed soil mass location and a mound of soil pushed up at the west toe of the embankment (Figure 18a). The embankment failed along a length of approximately 150 m at a location where a low-lying softer soil was located at the toe. No geotechnical information could be found for this specific location. However, the soil conditions nearby consist of about 4 m of sandy silt and silty clay (SPT values below 20 blows/foot) underlain by cemented sandy silt, locally known as “tosca.” Geotechnical information found for this area shows that the location of the phreatic surface varies seasonally from 1 m to 9 m deep (Figure 19).

Figure 19. SPT and DCPT data in the Copihue area (adapted from MOP 2010). Pre-earthquake data.
